## Final Report

### The Collection, Treatment and Reuse of Nursery Runoff Water

Prepared by: Ted Allender, ERA Nurseries

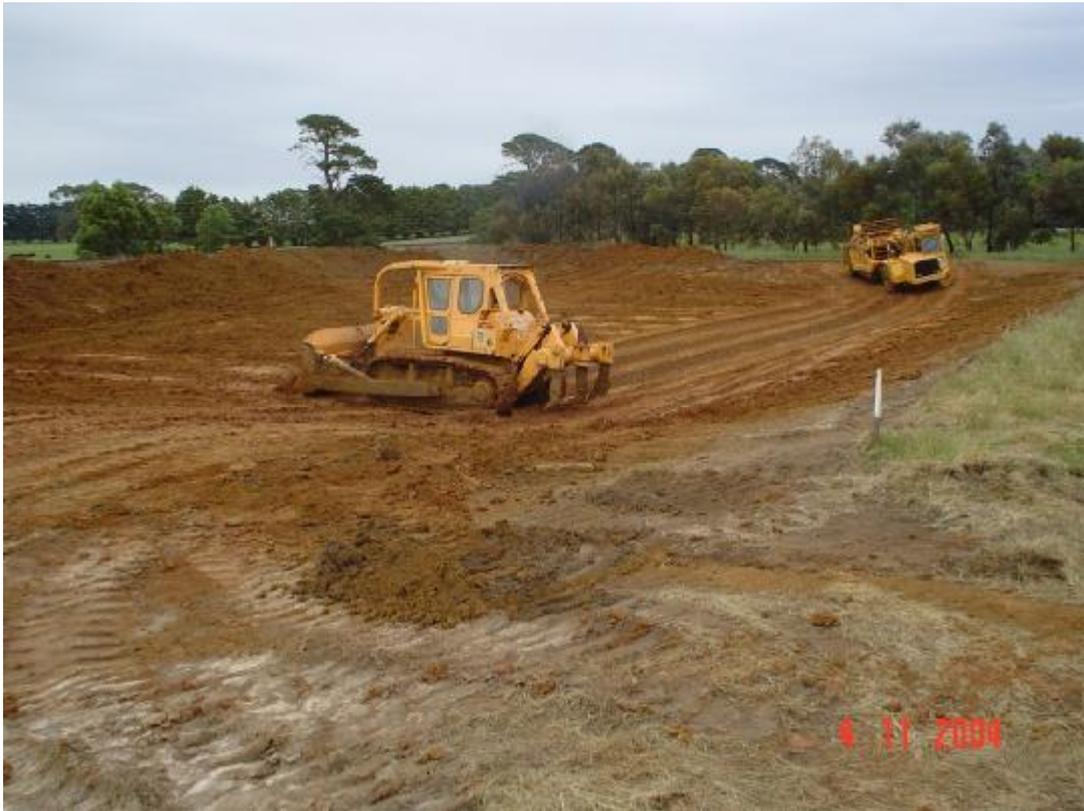
November 2004. Excavation of the storage structure was a major task requiring large amounts of material being carted from the site.

The storage dam is a large structure originally of approximately 5 MI capacity. It was extended in April 2007 to approximately 6 MI.

Because of favourable sub soils, the dam has been excavated to significant depth so that overall surface area to water storage volume is relatively small thus minimising losses through evaporation.

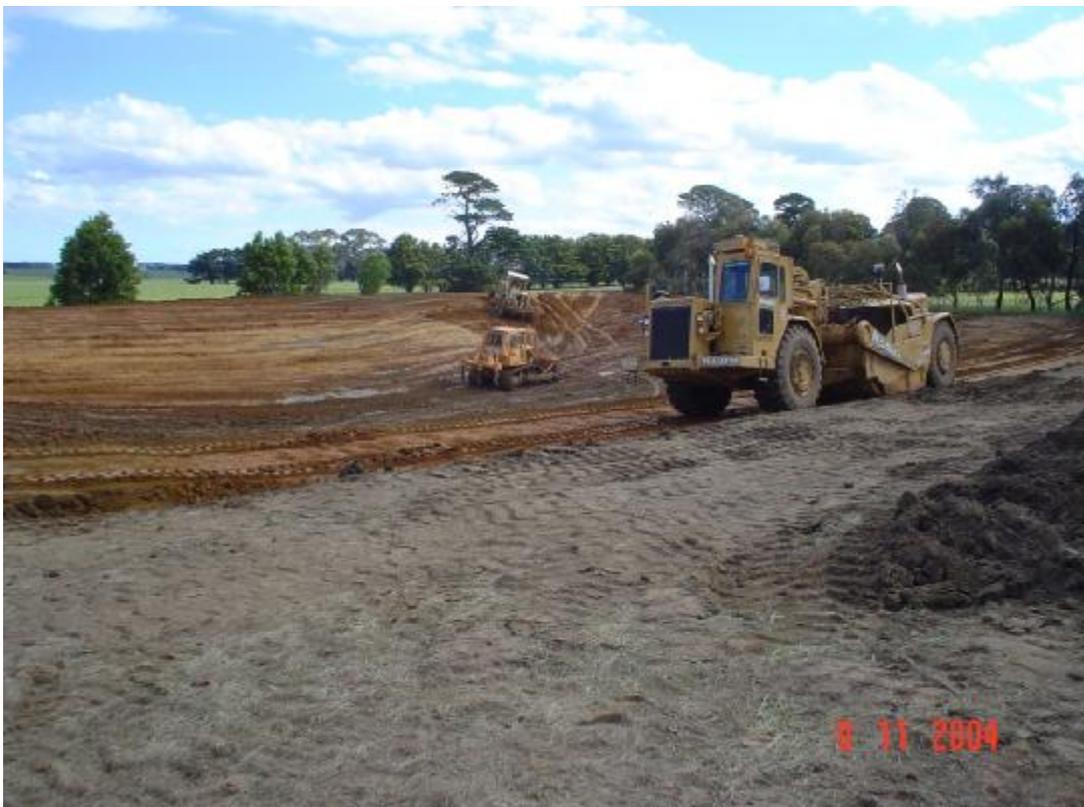
November 2004. Due to site constraints the storages have been constructed to be as deep as possible with the minimum surface area. There was abundant clay on site to line the structure.

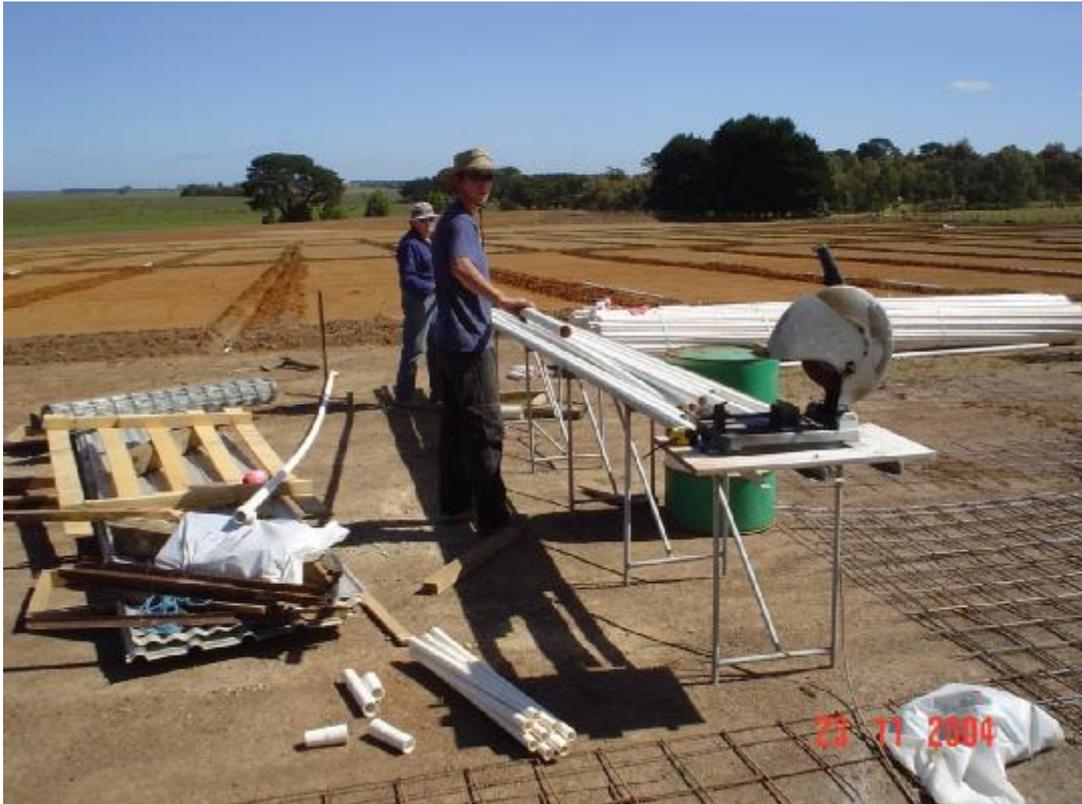
November 2004. Irrigation and drainage/collection networks being fabricated and installed

There are some 2 km of cut-off drains and associated pipework running through the entire nursery property. All rainfall and irrigation runoff is collected and channelled to the primary collection dam. Earth bunding has been constructed to channel water to the primary dam in the event of an extreme rainfall event and in circumstances where the subsurface drainage system is unable to cope with stormwater volumes.

The cut off drains consist of 900mm slotted PVC pipe located in a 300mm x300mm trench filled with 20mm screenings.

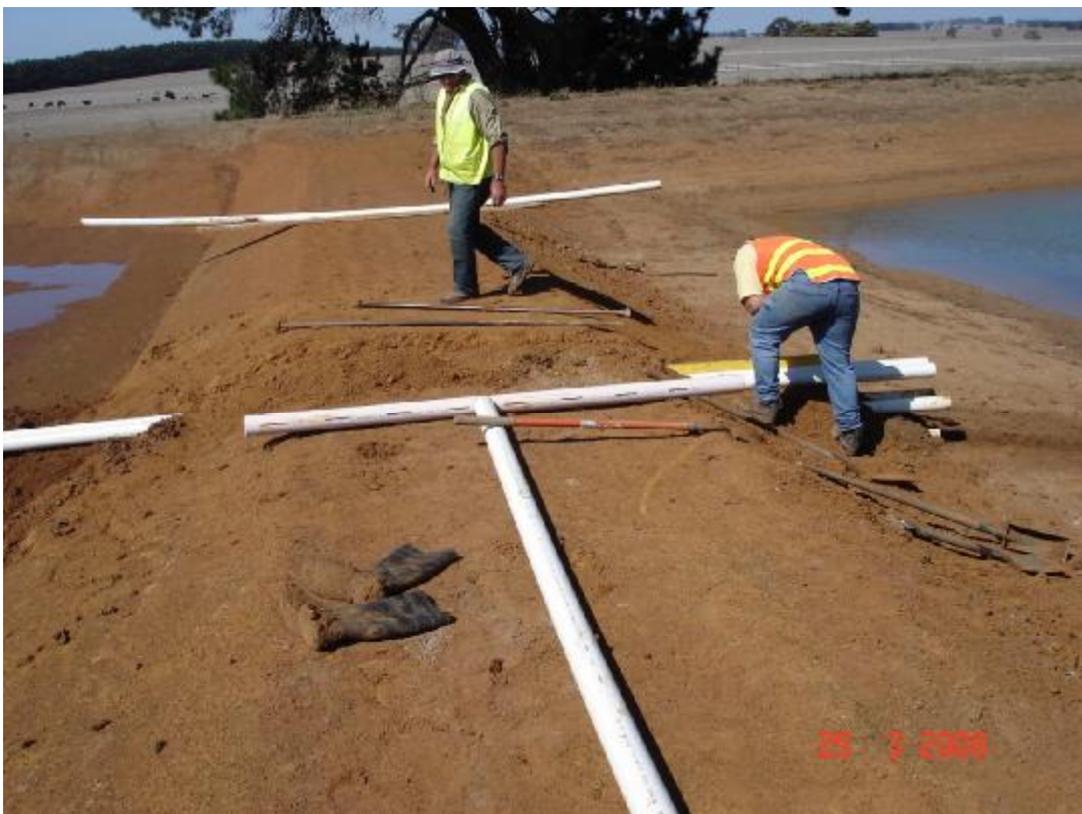
March 2006. Work being undertaken on the reed bed filtration structure

This clay lined structure is approximately 34m x 11m in area and is filled with fine 7mm gravel to a depth of 500mm. The filtration media is comprised of 65% gravel and 45% water when inundated. Around 84 kl of water is in the treatment zone at any one time and whilst in residence the reeds actively take up nutrients and other pollutants from the water.

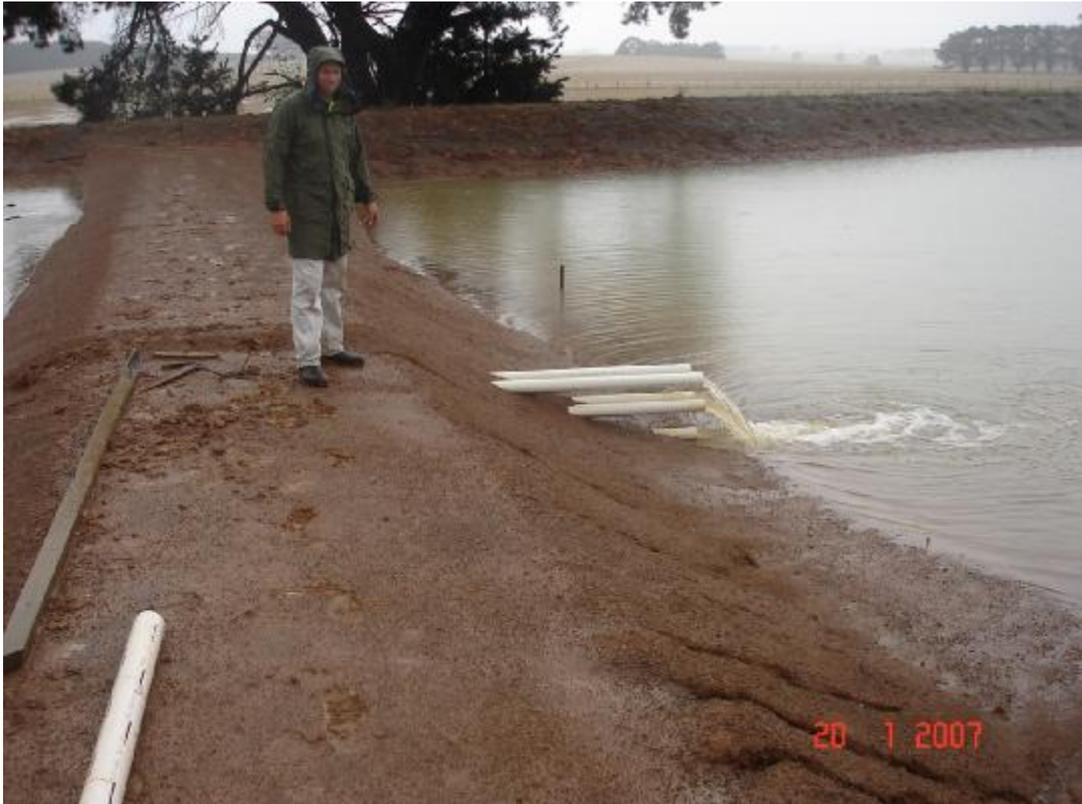
January 2007. A 90 mm in 24 hours rainfall event caused significant damage to the partially completed earth structures

In the early days we experienced a couple of severe rain events which came close to destroying the earth banks surrounding the reed bed.

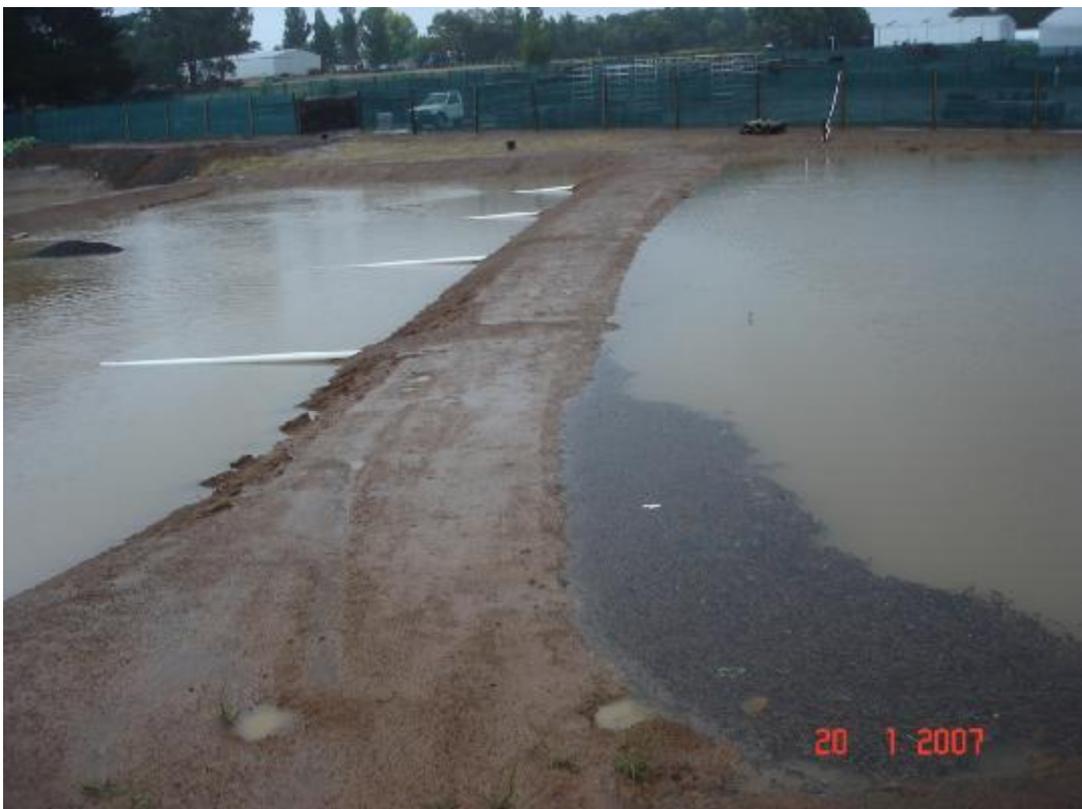
This and other similar events vindicated the decision to construct a surge diversion component to the system.

This surge diverter was constructed in late 2006. It is a concrete structure located near the inflow point on the primary collection dam. Its purpose is to divert stormwater inflows through a large diameter pipe in the event of the system being subject to inflows in excess of the capabilities of the overall system.

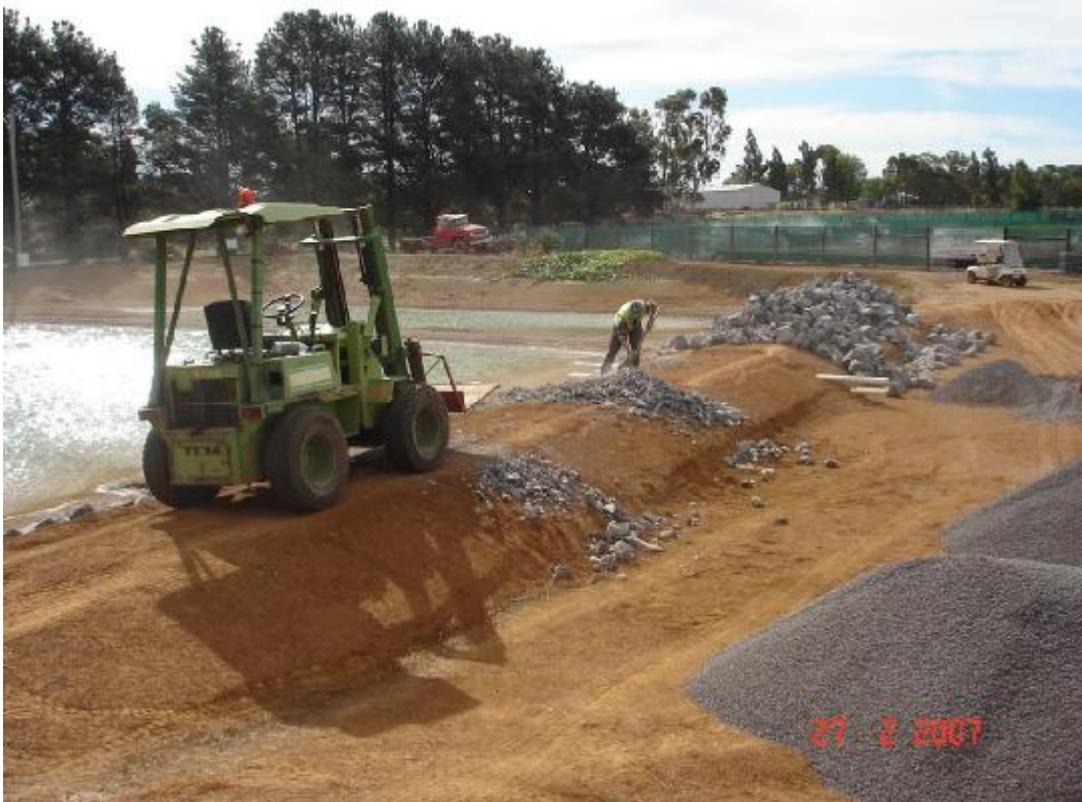
February 2007. Extensive rock walling and beaching in the storage and reed bed areas is being placed to reduce wave action and rain impact erosion to the earth structures.

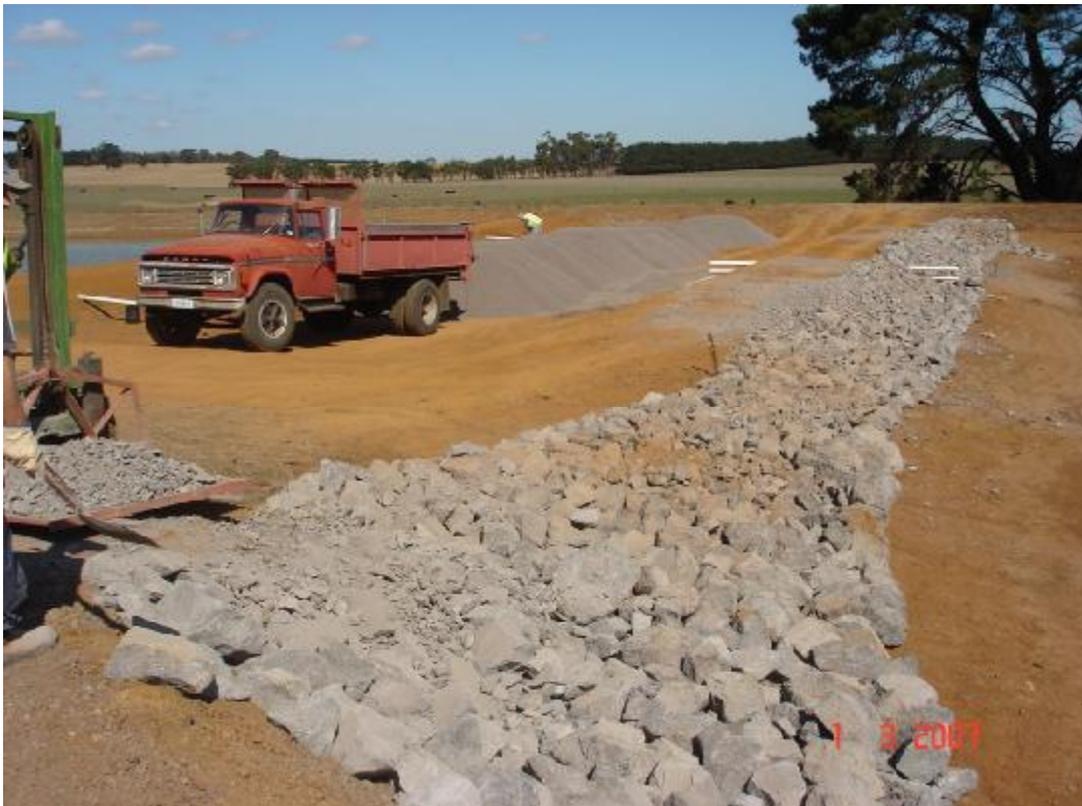
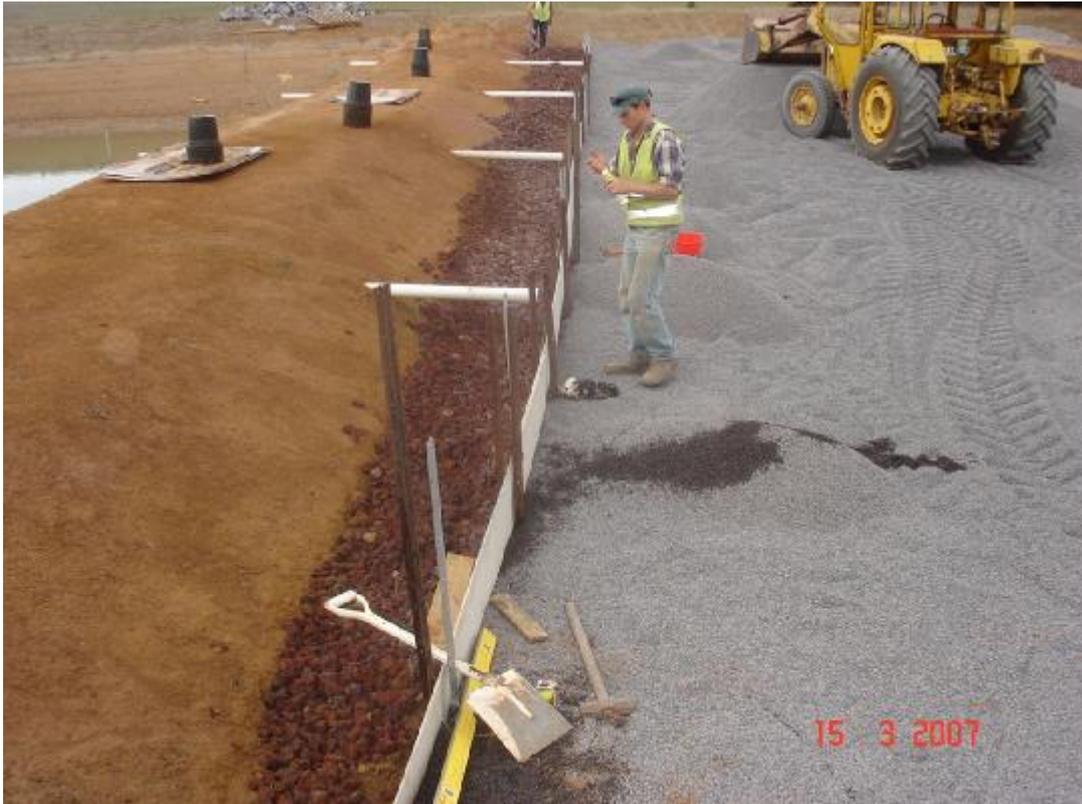
March 2007. *Extensive pipe networks are designed to ensure that the highest level of flow uniformity was achieved through the gravel media.*

An elaborate array of pipework means that all water entering the system is uniformly distributed. Similarly, water leaving the system to storage is also evenly distributed. Water levels in the reed bed can be easily adjusted to allow for maintenance.

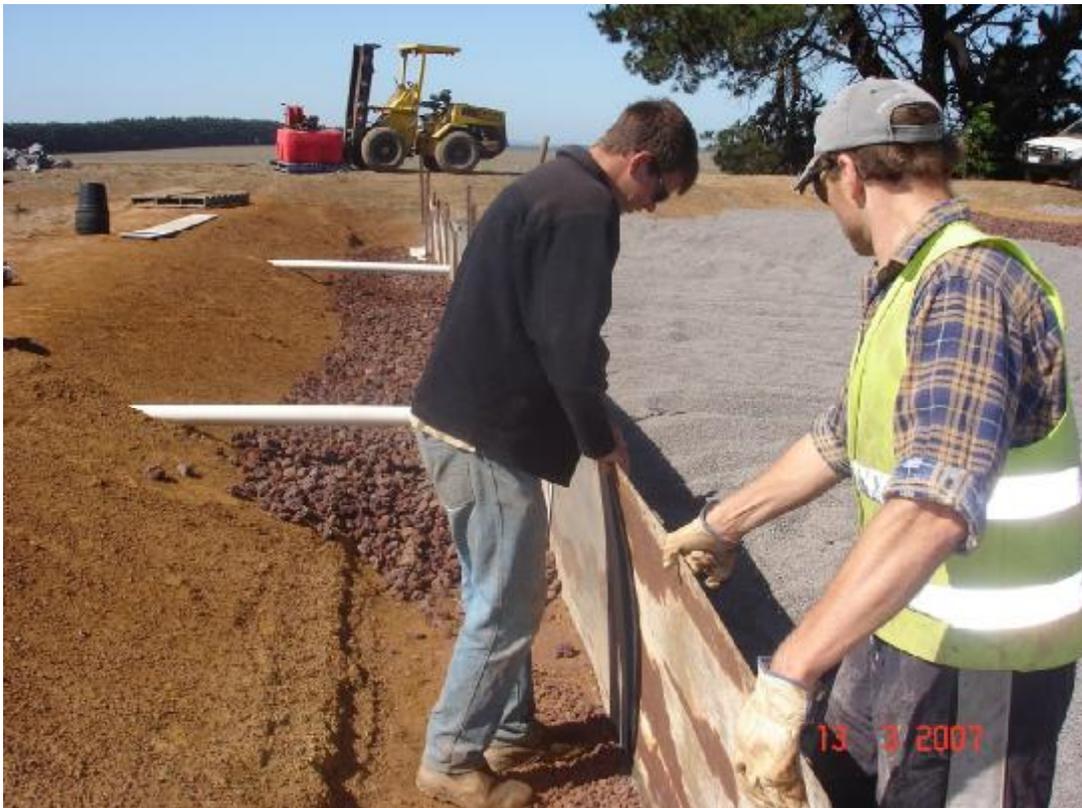
*Installing the inflow manifold to the reed filtration structure*

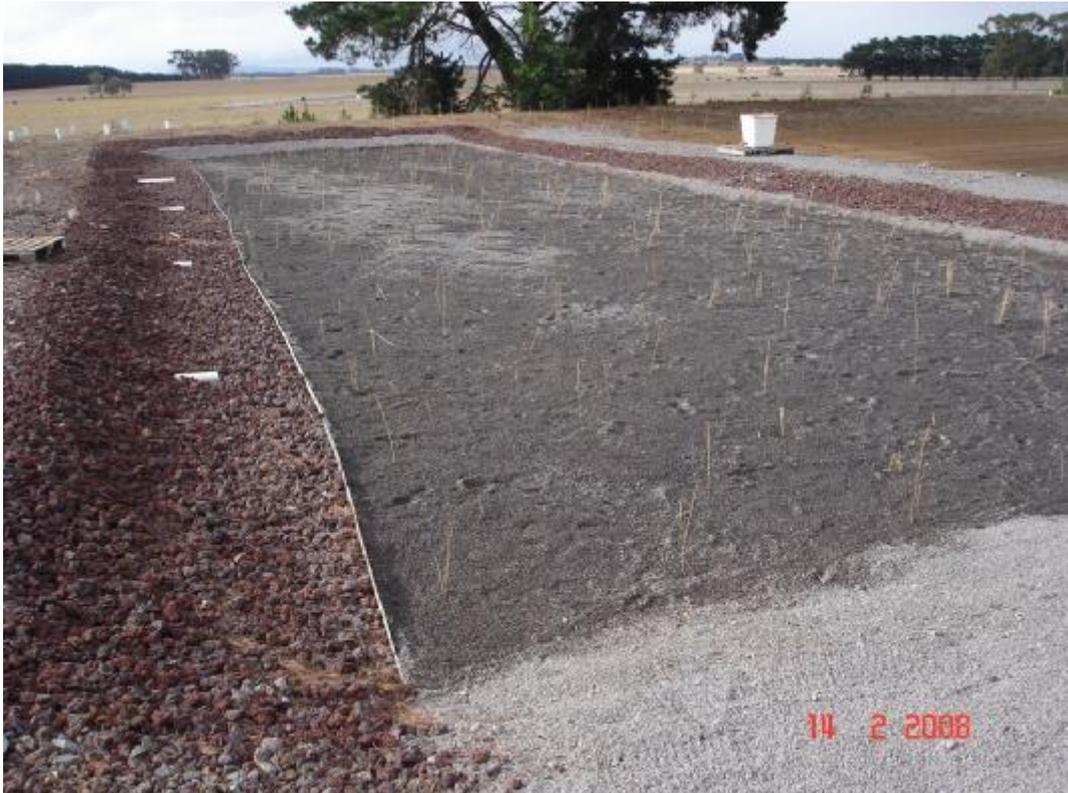
February 2008. *The reed bed has been planted with rhizomes of common reed and inundated to allow the subsurface portions of the plant to develop and produce new emergent shoots.*

The filtration system was planted with common reed in 2008 and over the last 2 years it has become well established.

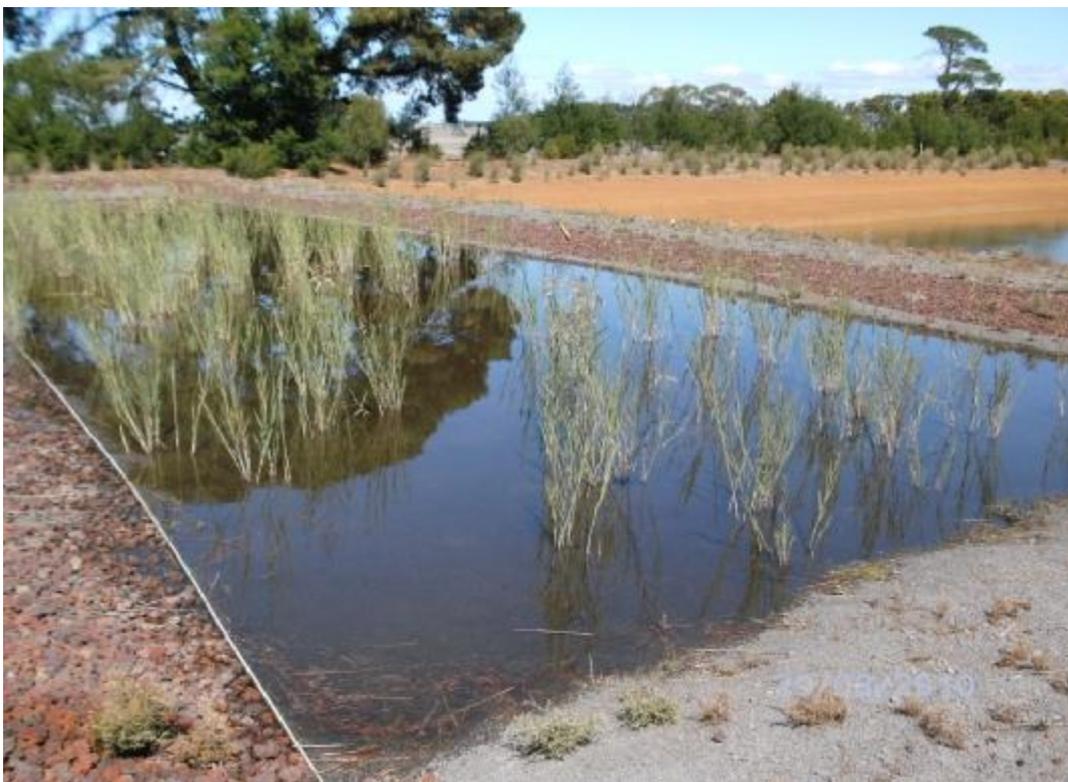
March 2010. *The same aspect showing considerable development of the reed bed. Also note the development of the landscaping elements in the background. It is essential to keep these aquatic plants inundated at all times.*

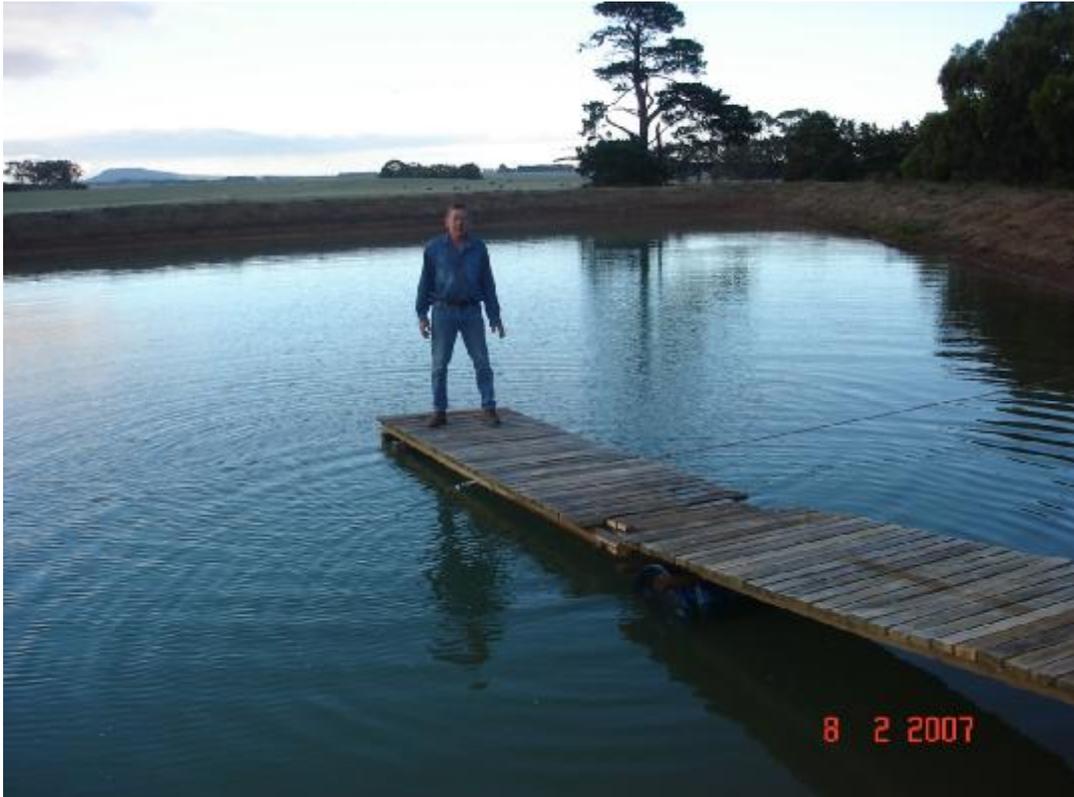
February 2007. Storage dam showing pump off-take floatation structure

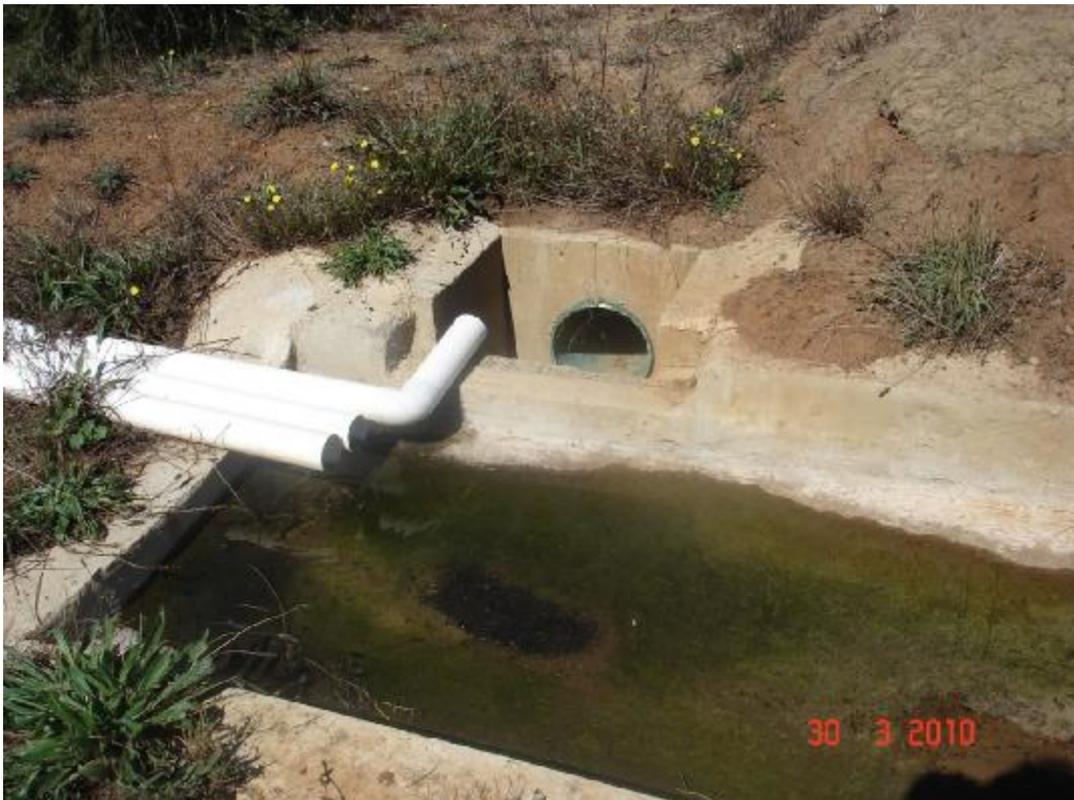
Surge diverter showing spillway which is set at an exact level to prevent stormwater flowing over earth banks downstream.

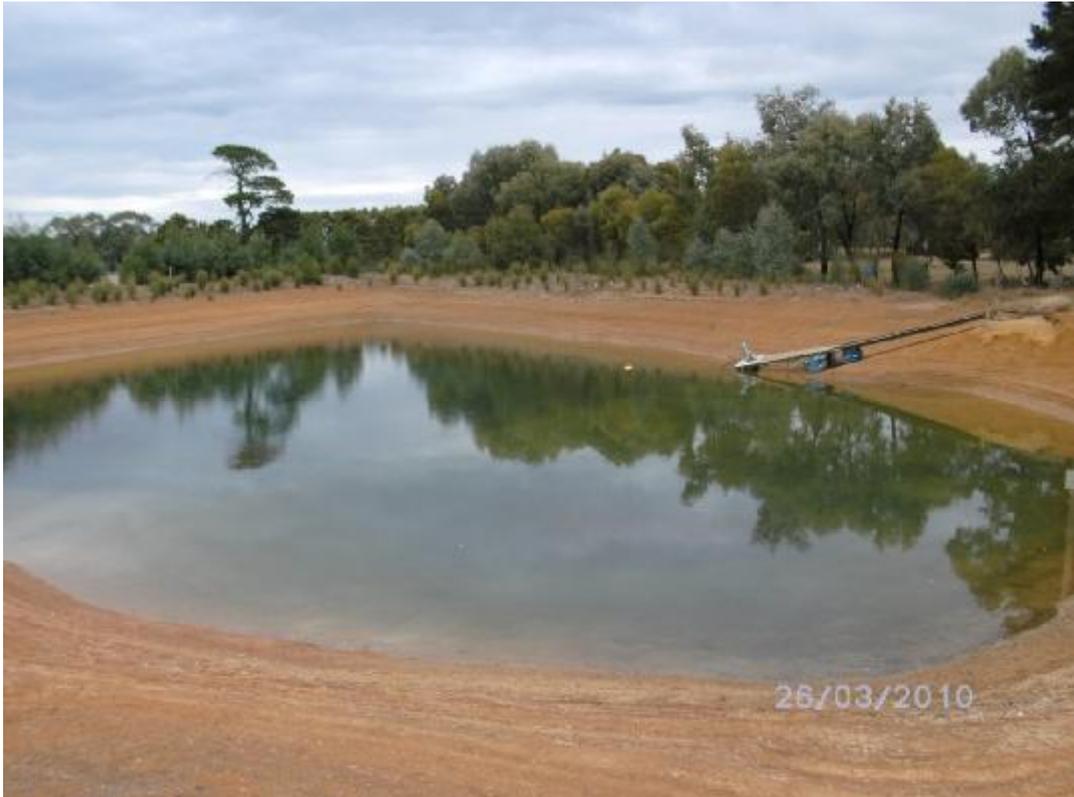
March 2010. *Main storage dam towards the end of the irrigation season. A minimum water level is maintained to ensure the integrity of the clay lining is maintained*

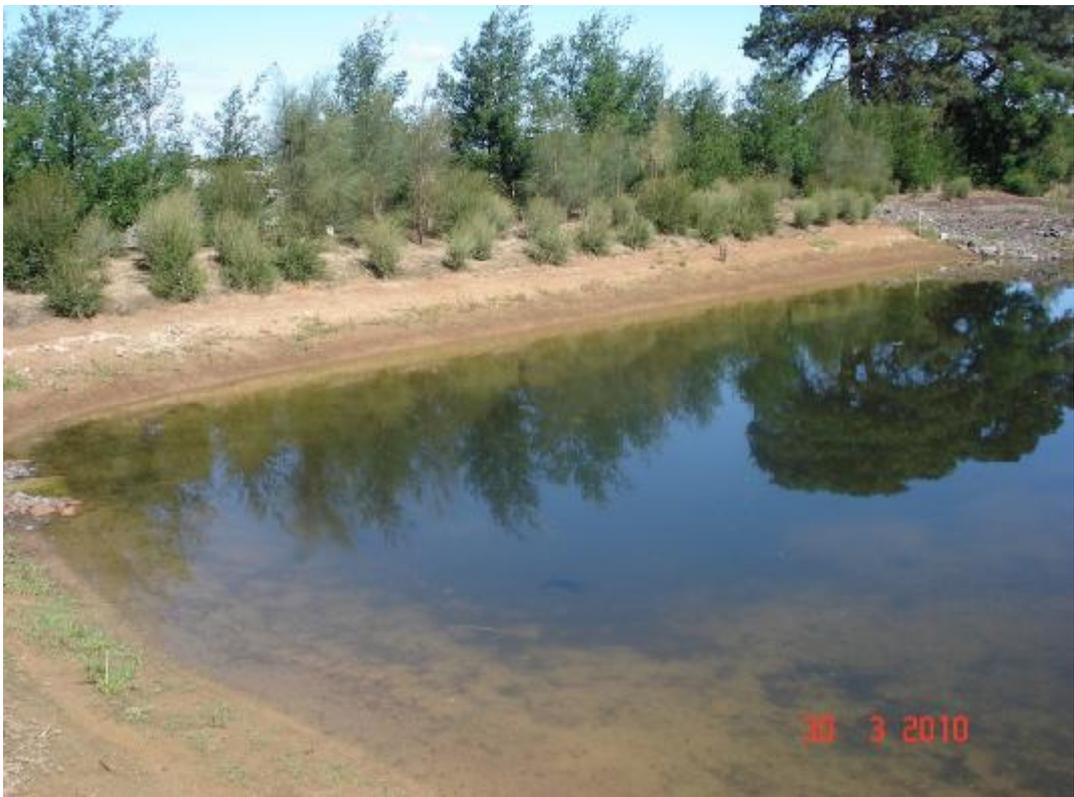
March 2010. *Extensive plantings of indigenous species reduces bank erosion, reduces wind flow over the water and provides habitat for a wide range of bird and animal species.*

There have been multiple strategies developed to reduce evaporation. The first of these is the extensive windbreak planting referred to earlier. These comprise local species and are densely planted and will be effective in reducing erosion of earth banks. Growth development has been relatively slow given that these clay lined banks have been heavily compacted during their construction.
